Part 4a of the Royal Portal Series

January 2021

Chartres Royal Portal - colonnettes vandalised

John James

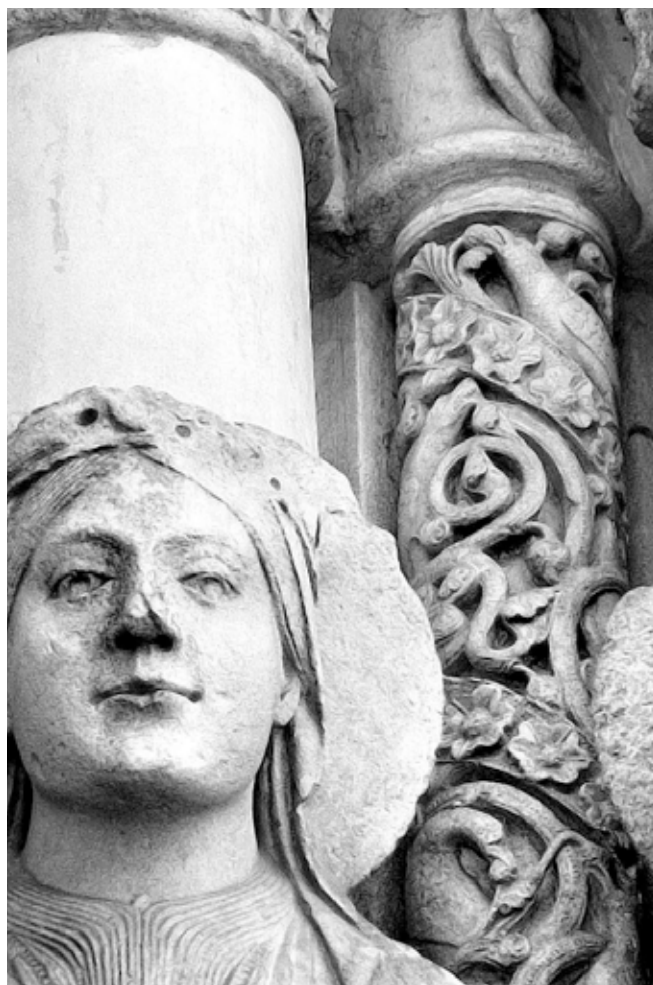
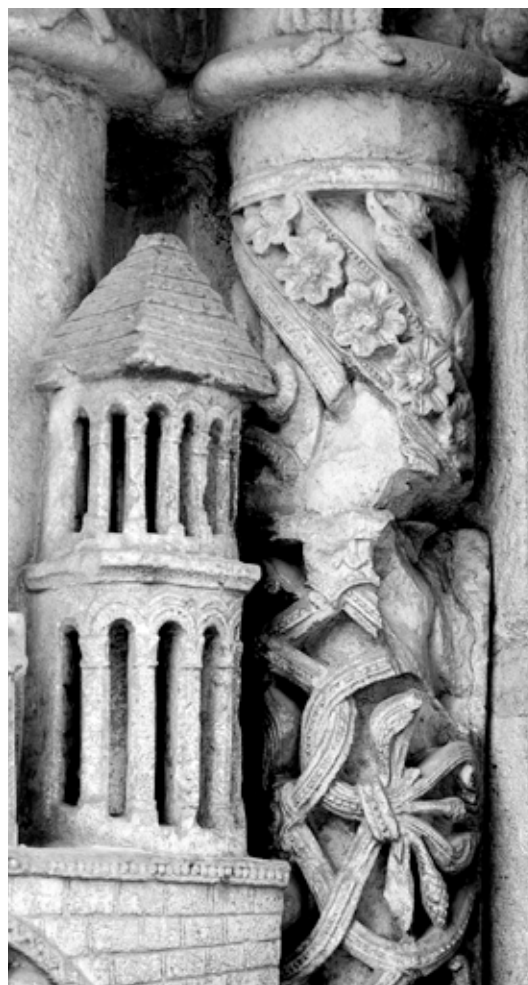
For example [b], on the left the top is finished with a ring, and the bird's delicate head sits comfortably against it. This stone is about 1.2 metres long. On the right there is a short piece to the same design with the same little flowers along the spiral strap. But the bottom edge is broken and sits against a shaft with a very different design, and above that a block of mortar bridges a gap between the shaft and the capital. It looks like the piece on the right came from the bottom of the longer length on the left, and was turned upside down, and even though it was meant to fill the space additional mortar was needed as it still did not fit.¹ This was not the only example of mutilation. Indeed, twenty out of forty-three have been shortened.

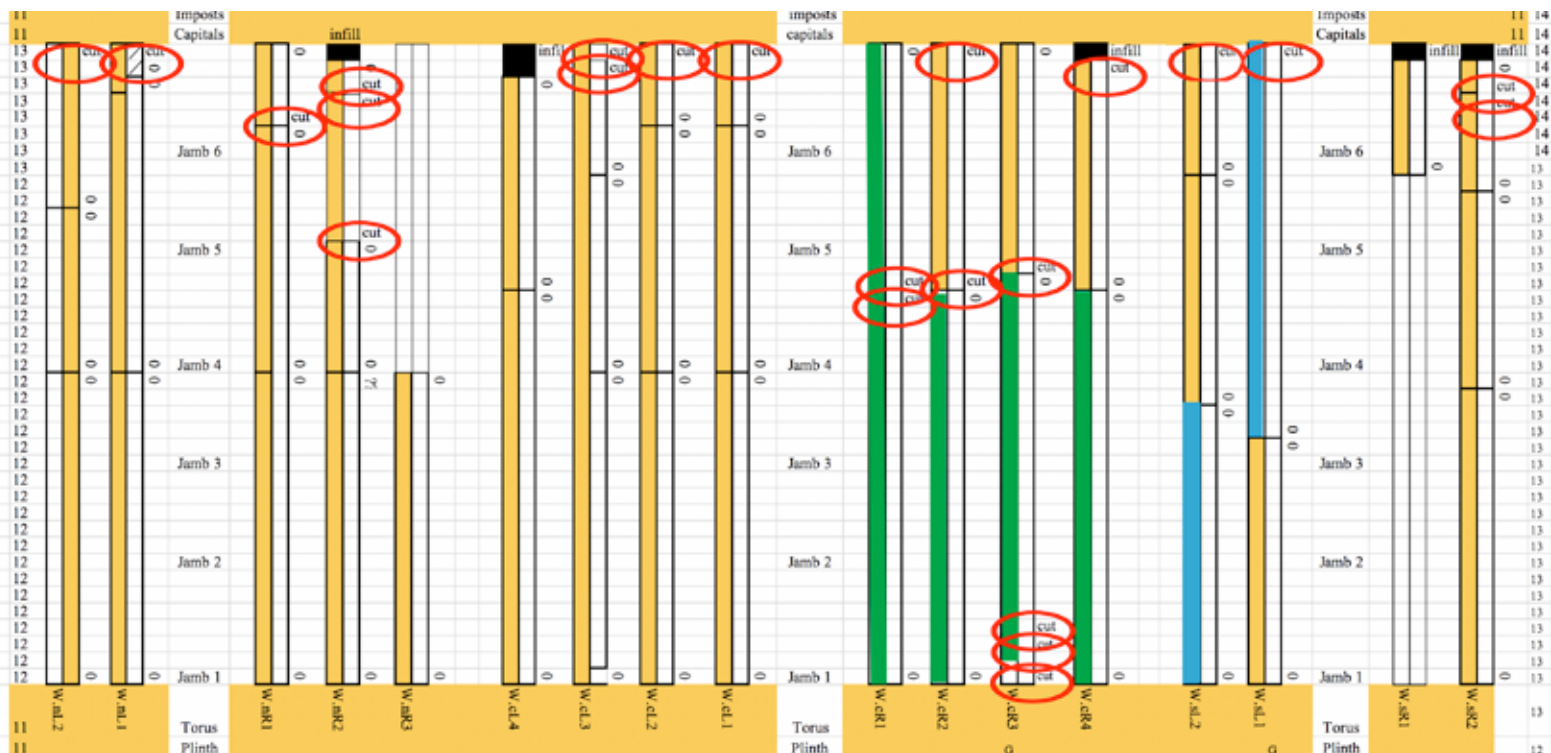
Twenty shafts out of forty-three were shortened [b], three at both ends, and

Schematic colonnettes, showing assigned teams and location of cut colonnettes. As the embrasure were erected over some years I have had to distinguish the process of carving, erection and truncating by campaign, and so to separate when they were carved from when erected. This is illustrated in two columns, with the carving campaign on the left and their erection on the right. They were almost never erected by those who did the carving.

the discards thrown away.³ Two are illustrated on the first page, and some of the others at the bottom of this page. Some are hard to see, but once we know what to look for, it is obvious that nearly all the upper shafts immediately under the capitals had been reduced. They are marked “cut” in the schematic and highlighted with a red circle.

It is clear which have not been cut as they terminate at each end in small ring-like moulding, marked “0” on the schematic [r]. Some of the scraps are only 20cm long, some as much as 120cm. In five instances they could not get it right and had to fill additional gaps over the shafts with mortar, marked “infill” and coloured black in the schematic. The truncations show they were not erected by those who did the carving.

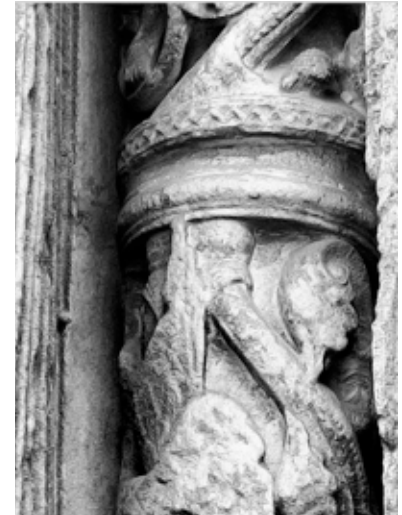
The ring moulds that terminate the uncut shafts

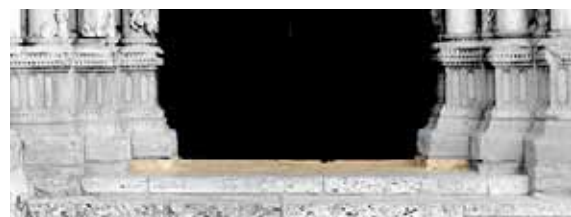
The width of the north door, and this door only, was firmly established by the single stone that forms the threshold [r1]. It is unique in having upstands at each end that locate the plinths on both sides. I have assumed that, along with the plinths and capitals, it was the work of Master-11^(F)¹⁵ Today the door measures 1.945 metres wide by 5.245 metres high.¹⁶ Deduct the plinth and bases at the bottom, and the capitals and imposts at the top, and the space left for the colonnettes is 3.58 metres.

North door threshold with upstands for the plinths.

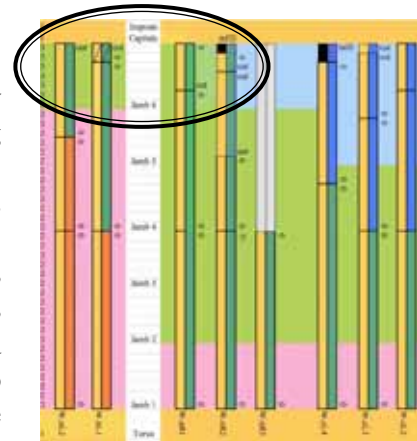
North end of portal, campaign-13.

The shafts flanking the north door were the first to be cut. This was by Master-13^(H) with the topmost embrasure on the north pier [green]. The erecting gangs just chopped the shafts into short lengths to make them fit, circled [r1]. Five in this campaign were truncated, one at both ends, and so began the chaos we see today. Most were placed at the top where they would be less noticeable.

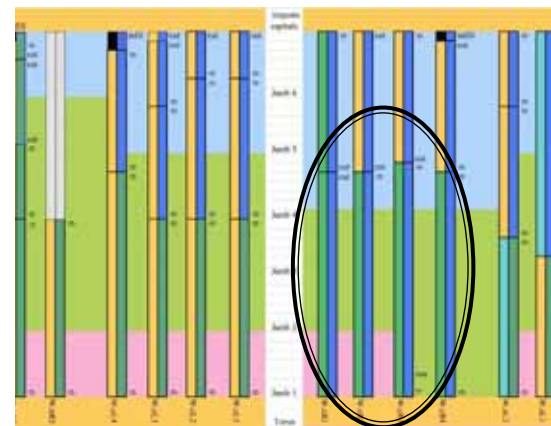
Once again, the same lack of communication produced a repetition of the earlier story. On each side of the central door the large number of courses laid by Master-14^(I) [blue] suggest this area had been held back, and with it the central lintel and tympanum resting on it.

Central part of portal with Interlock shafts circled

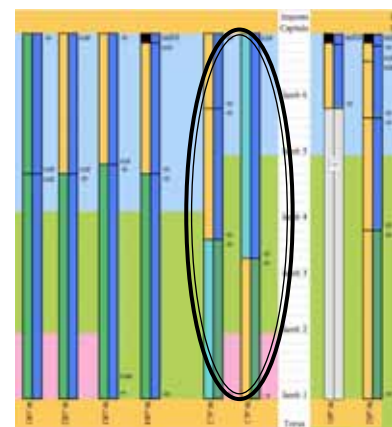
South end of portal, campaign-14.

They soon realised that at this rate they would be running out of shafts and there were not going to be enough to finish the job. This was a builder's problem, the *imagiers* having moved on long before. This is when they would have decided to carve the four longest shafts [dark green], each around 2.3m to suit the taller doorways,²⁹ to the same template, circled [r2]. As all but one of these were cut down, they must have been erected in the later campaign-14^(I) [blue].

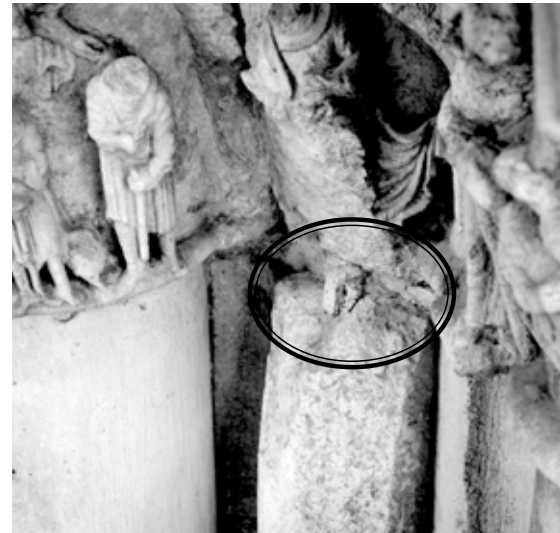
Also, there are cases where a campaign of walling stops just under the capitals, such as in the north embrasure. This allowed time for the wall to settle before the pin into the tops of the *en delit* shafts were fixed into the capitals.

The hooked iron let into the top of the shaft.
