## Part 6a of the Royal Portal Series

### *Chartres Royal Portal - the cracked central lintel'*

John James

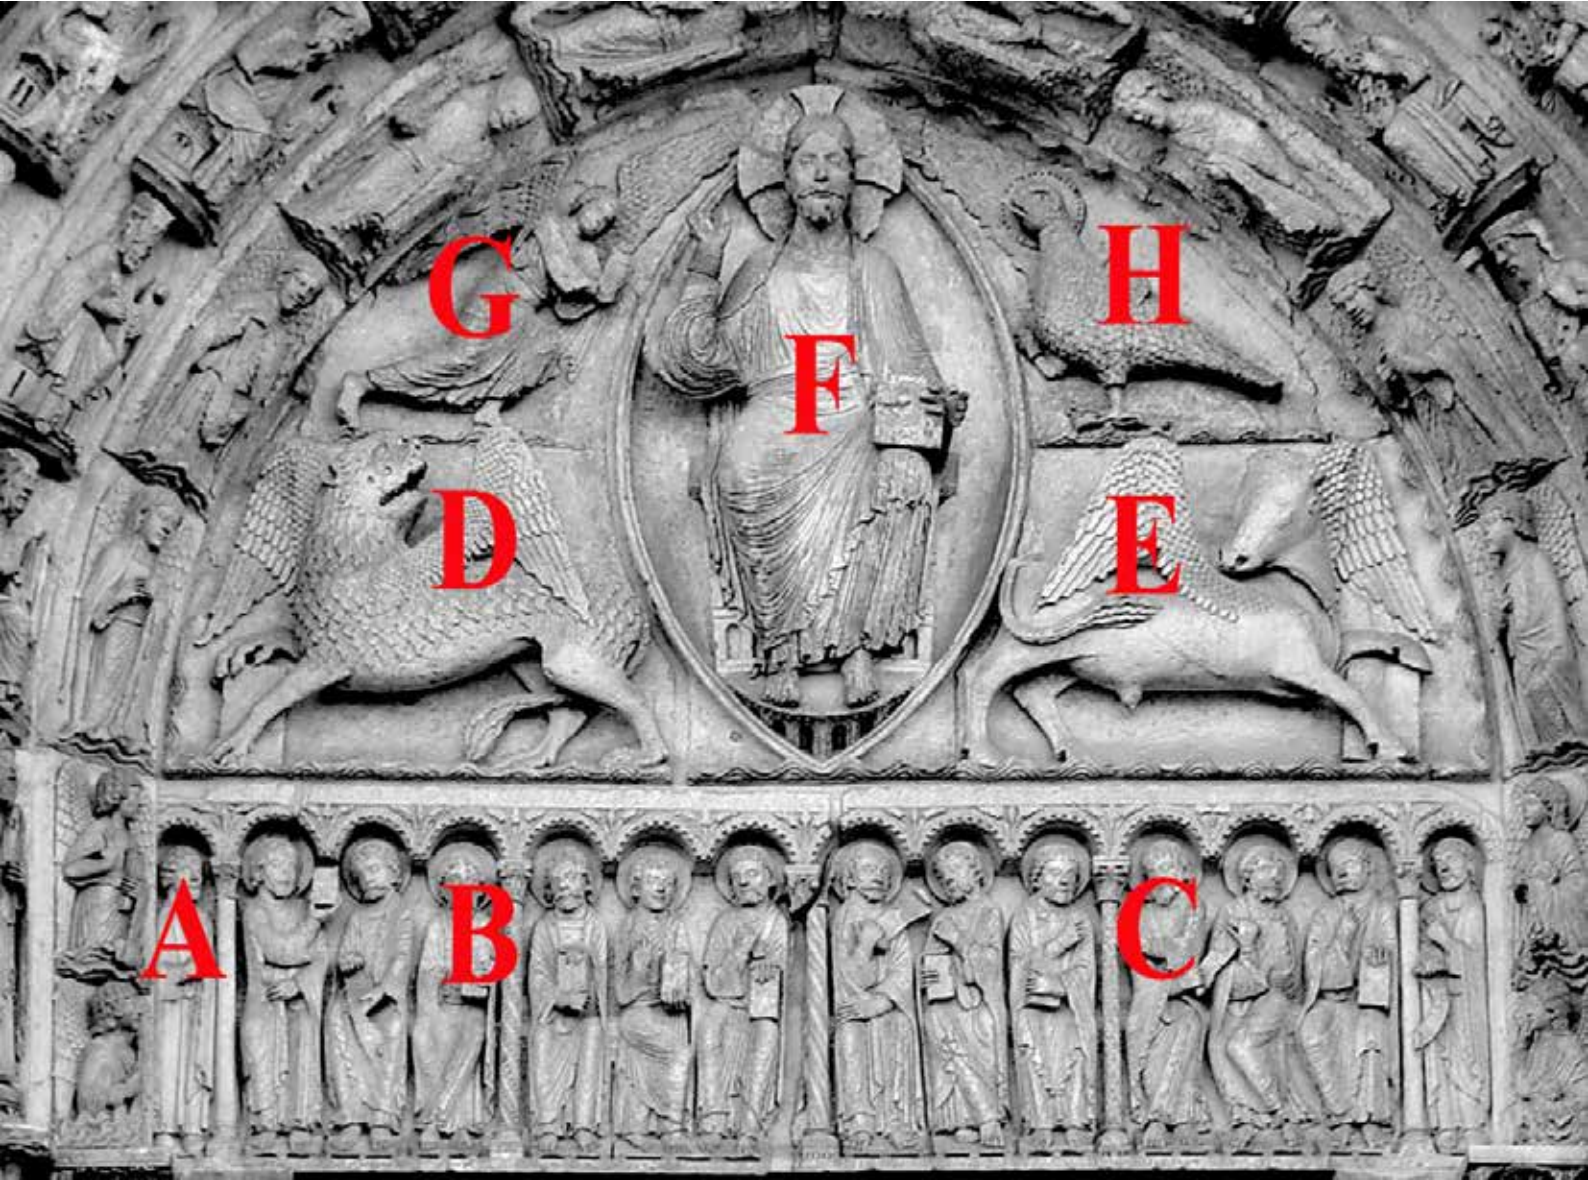
The lintel under the central tympanum of the Chartres Royal Portal is an enormous stone that would have weighed almost seven tons,<sup>2</sup> equivalent to a loaded six-wheel refrigerator truck. There are two vertical cracks through the lintel. The more obvious is in the middle, and passes through the shaft between the apostles. The other is on the left and passes through the second figure. The three parts of the lintel are marked A, B and C [a]. The lintel supports the five stones of the tympanum, in the centre for the figure of Christ within a mandorla, and four for the Evangelists.<sup>3</sup> The stones on the right meet as they should - C, E, F and H – as do the three on the left - B, D and G. The latter are twisted clockwise to leave a gap that gradually gets smaller from the crack in the lintel to the top of the mandorla F.

The scan shows that the vertical axis shifted. The centre through F is 5.5cm to the right of the axis through the door. When it cracked, lintel A was pushed 6cm to the north so that part of the canopy over the left figure disappears behind the archivolt, C was pushed 11cm to the right, while B twisted clockwise yet remained closer to its correct position over the centre of the doors. The net space for the lintel between the archivolts is today 10cm more than intended before the crack. These movements show that the tympanum was not placed until after the lintel had cracked.

crack opens the beam pivots from the top, and as the opening at the bottom of the crack becomes wider the outer ends of the beam are pushed sideways. At Chartres the movement in the lintel pushed the stones apart, widened the space for the tympanum and shifted the axis to the south [r1]. If the lintel had broken after the abutments had been built the shift would have been minimal, for the encasing masonry would have resisted the lateral movement. This shows that the crack occurred before the encasing masonry had been placed.<sup>4</sup>

I will use the small discrepancies in position and measurement to show that the lintel cracked under its own weight as it was being lifted into position.<sup>5</sup> Direct measurements cannot be taken without scaffolding. The measurements used here come from the laser scan of the portal prepared by Andrew Tallon.<sup>6</sup> He considered the scan accurate to 5mm.

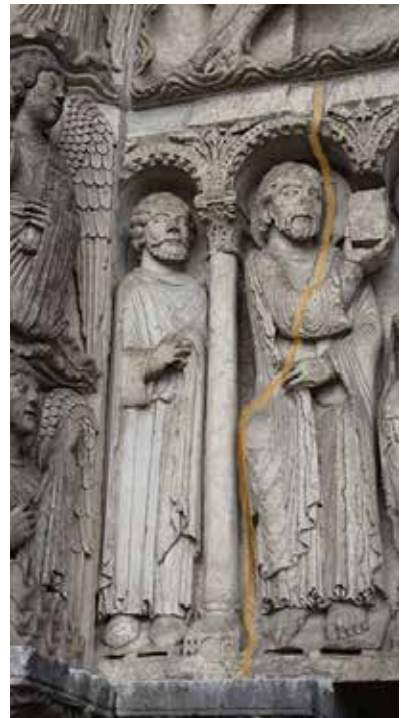
North end of lintel, arch over statue disappears behind architrave, approximate location of crack.

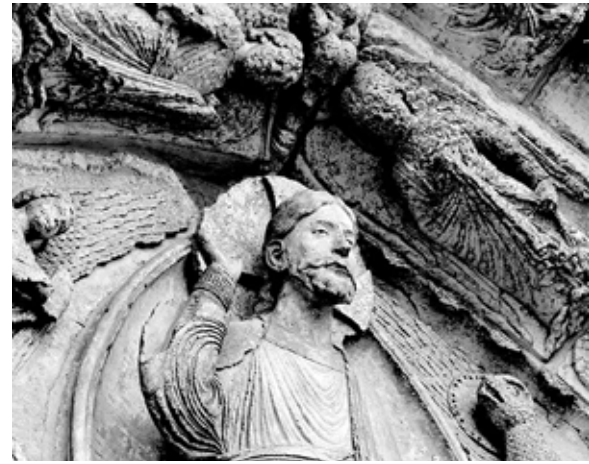
Broken end and upper edge to stone G above the halo to F, and the gap under the archivolt.

right corner of G may have been placed too close to the top of F because at some moment it broke. The pointed end that passed over the head of Christ may have been under strain as the stones were being manoeuvred into place and the narrow end broke. This may not have happened during erection, but when they removed the trumeau in the seventeenth century. That action could have caused a slight shift as the stones adjusted against each other and may have resulted in the small gap under the upper left archivolt [r].
