## Raising the capitals at Notre-Dame d'Etampes

John James

August, 2020

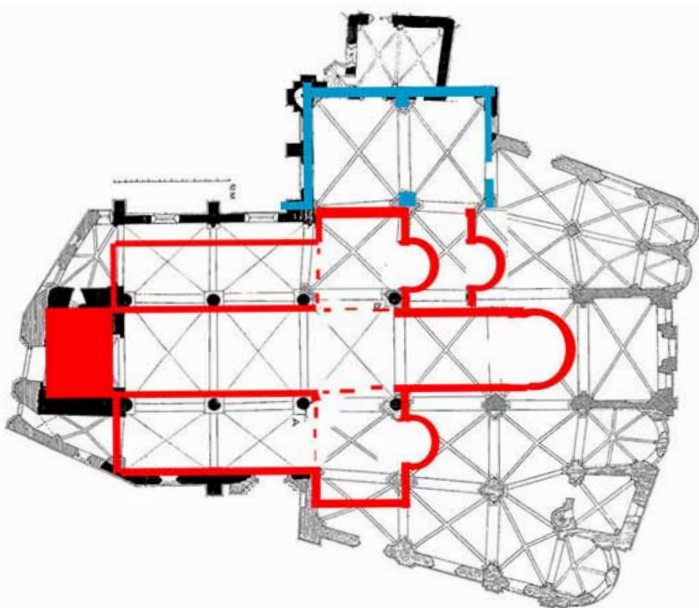
The First Church in red, the chamber in blue

A large chamber had been added on the north side of the church, presumably for pilgrims [below, blue].<sup>4</sup> It connected the church to the earlier ossuary, and there are still remains for parts of walls, evidence for central supports for the roof and doorways to the north and west.

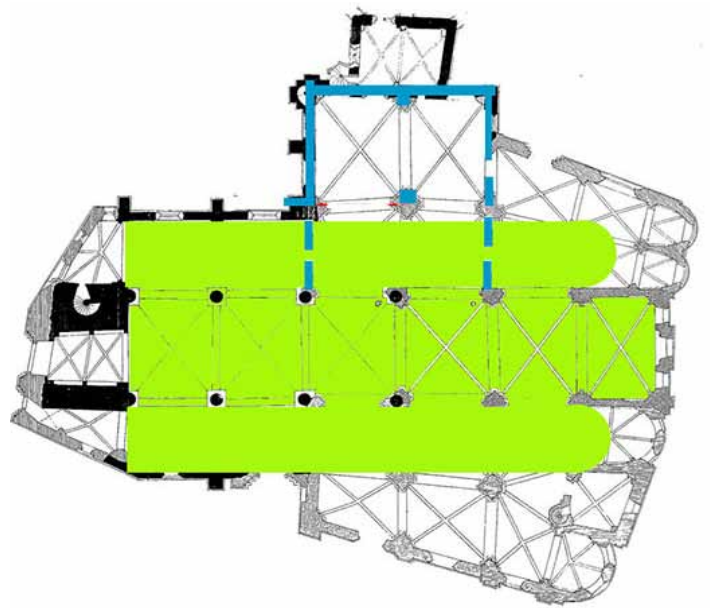
The intended Second Church in green, integrated with the chamber in blue

The Second Church had a three-bay nave with aisles to which was later added a matching three-bay choir with a square east end [next page]. The lateral chapels from the earlier church appear to have remained and been in the way, so the side chapels to the choir were not built, only starter blocks begun. This study will show that both nave and choir were built only to the height of the string course. Though incomplete, the design provided a considerable area for worship [green, bottom right]. The aisles of the nave were built around 1115, and the choir in the mid-20s.<sup>5</sup>

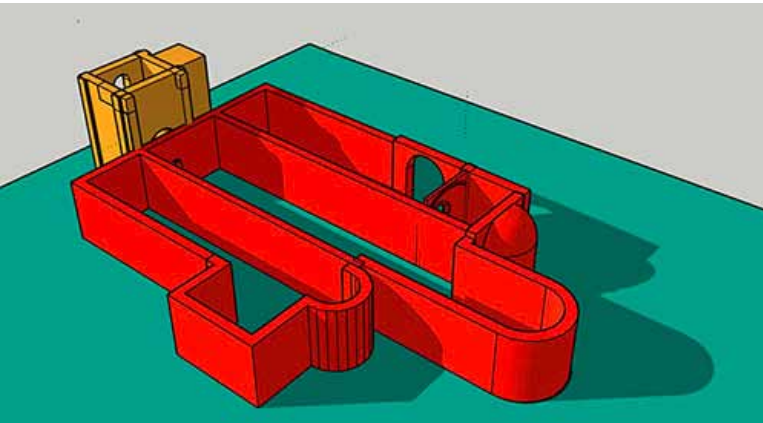
The First Church: choir and crypt, lateral chapels and nave against small tower.

The First Church would have had an apse over the crypt, following its outline. From a few hints that survive in the existing structure it may have had lateral chapels, though the nave that extended to the western tower is pure guesswork [next page, in red]. The image is derived from our best analysis of the model. I will be providing the evidentiary hints for this arrangement in a separate study.

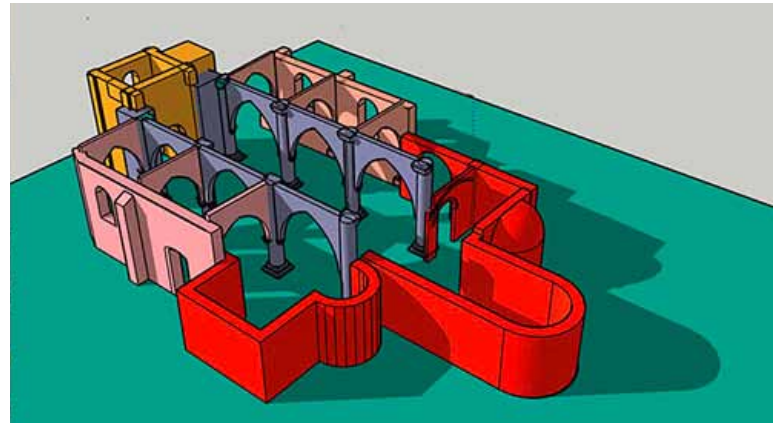
Nave of Second Church of three bays with aisles.

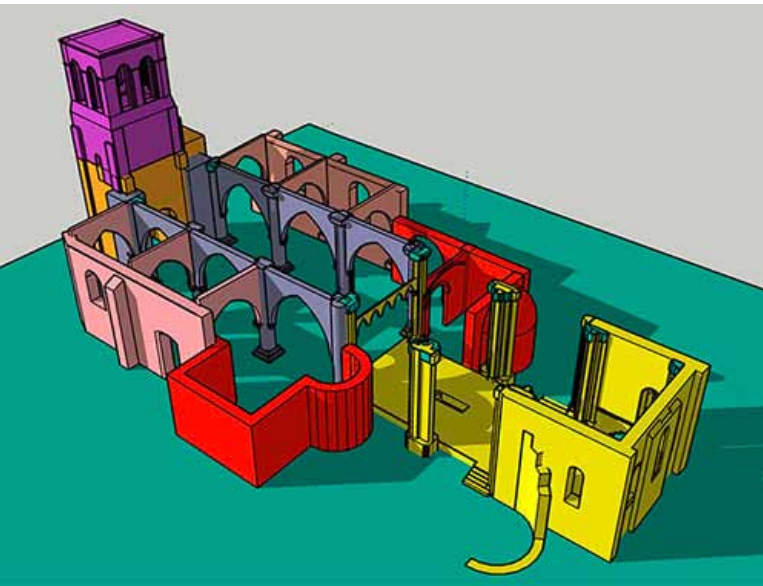
Choir of Second Church with older side chapels retained. Third and fourth stages of the tower added, either before the nave, or just after.

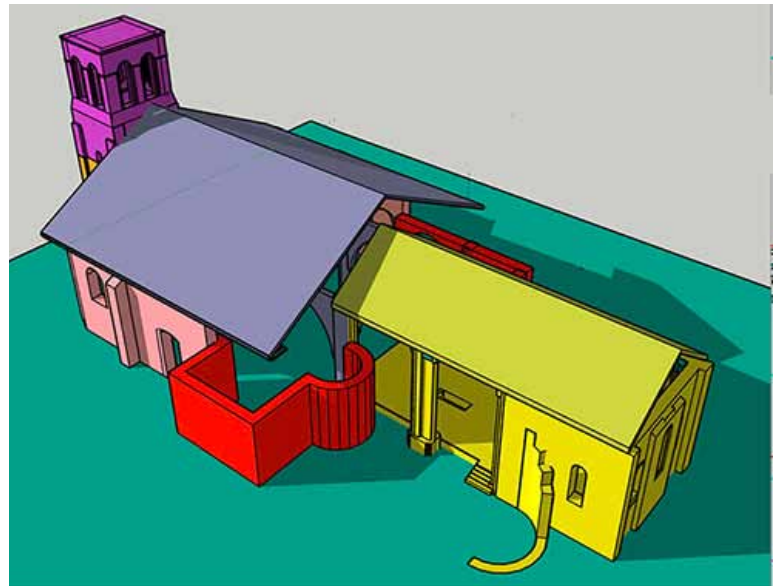
Roofs of some sort built over nave and choir to enable services to be continued in the new space.

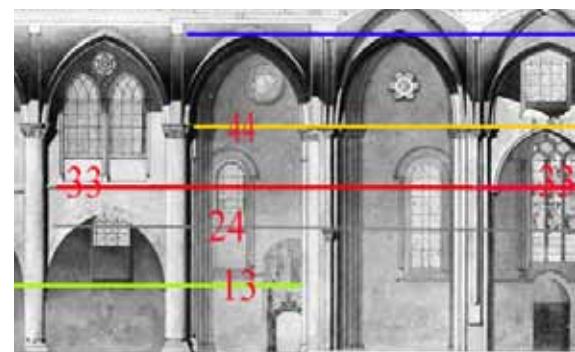
Section with number of courses, and 66 to the roof.

The capitals in the upper choir clerestory of the Second Church are now on the 44th course [right]. The designs are in the same mode as those in the lower level under the arches into the side chapels, at the 33rd course. There are another two that frame the entry to the choir on the crossing piers, at the 24th course and two more flanking the entry into the southern nave on the 19th. Being in so many different places and separated by so many levels requires a little explanation.

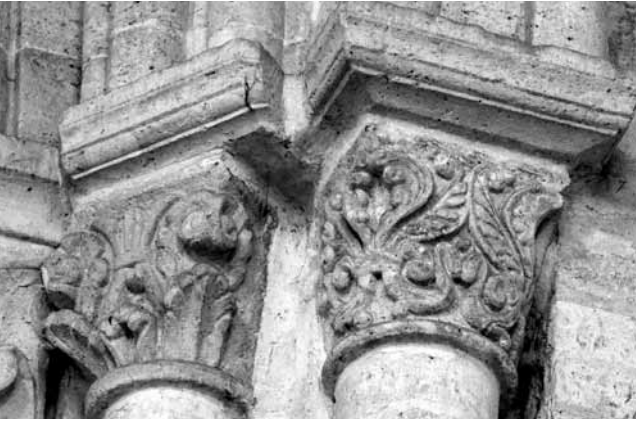
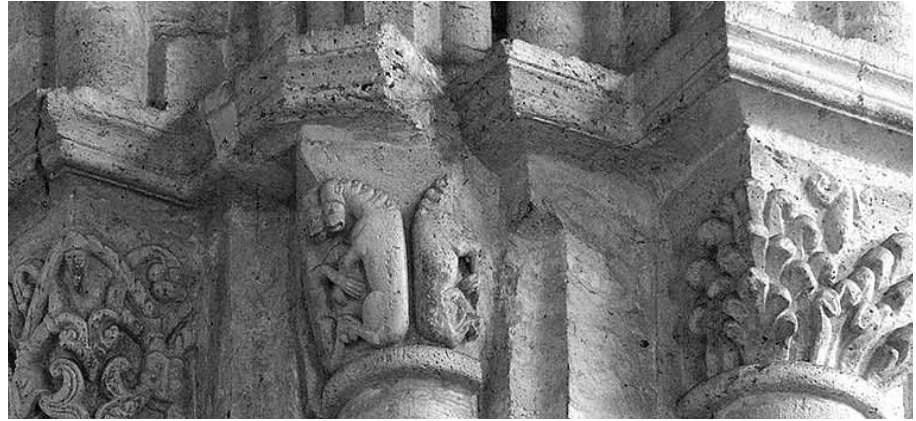
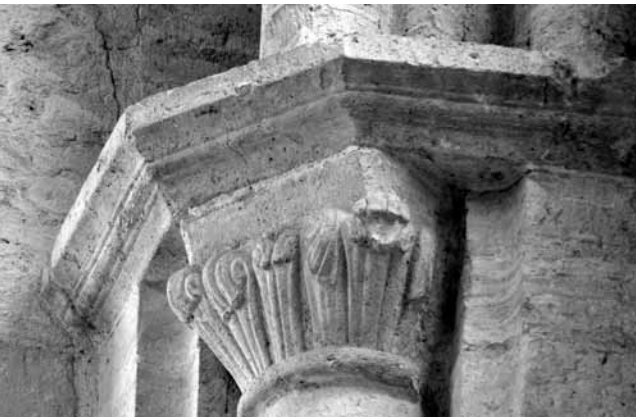
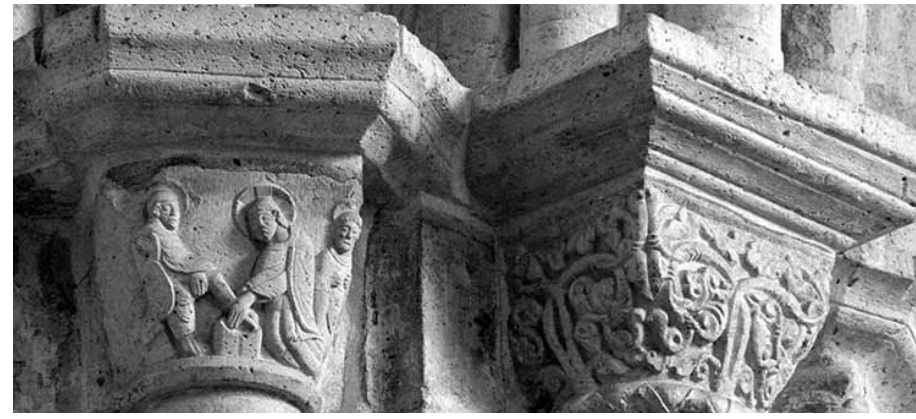
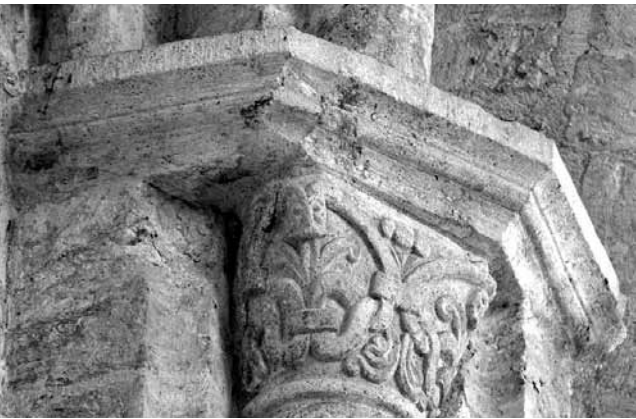
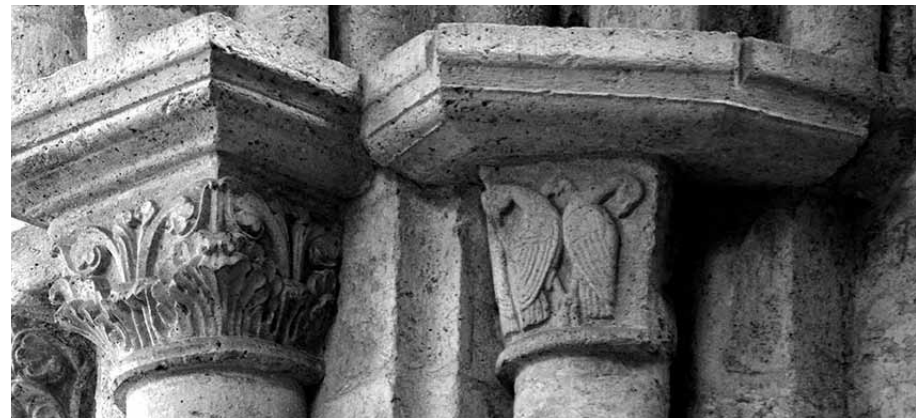
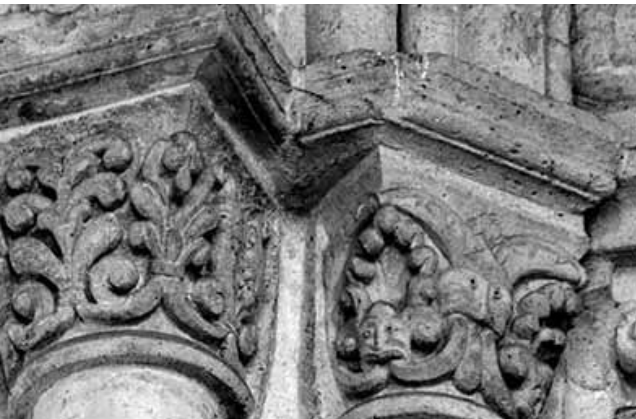
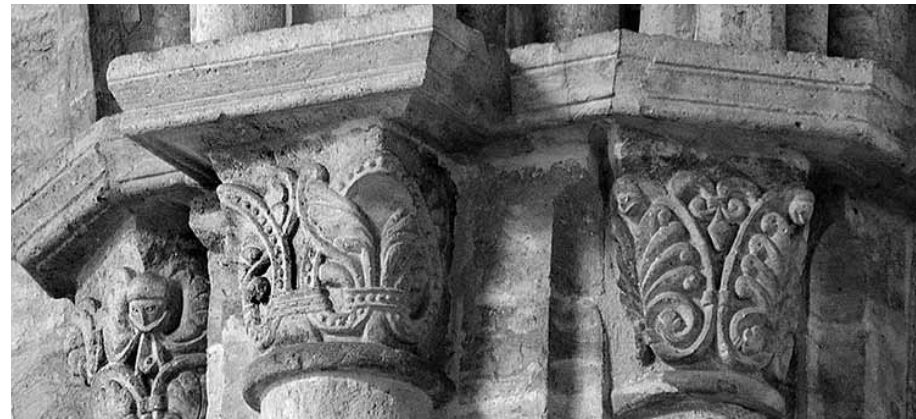
EN1ne choir (+) capitals

EN2sw choir (+) capitals

ES4nw choir (+) capital

EN3ne choir (+) capitals

EN4sw choir (+) capital

ES3nw choir (+) capitals

ES1e choir (+) capitals

ES2nw choir (+) capitals

All these capitals sit comfortably under appropriate imposts except those in the upper level of the choir. These capitals and their imposts are misplaced, altered in shape and size, and are often too small or too short for their location [next page]. The imposts are confused and mismatched to a degree that is unique in the church, for nowhere else has fine sculpture been so mistreated, nor has their relationship to their imposts been so ungainly.

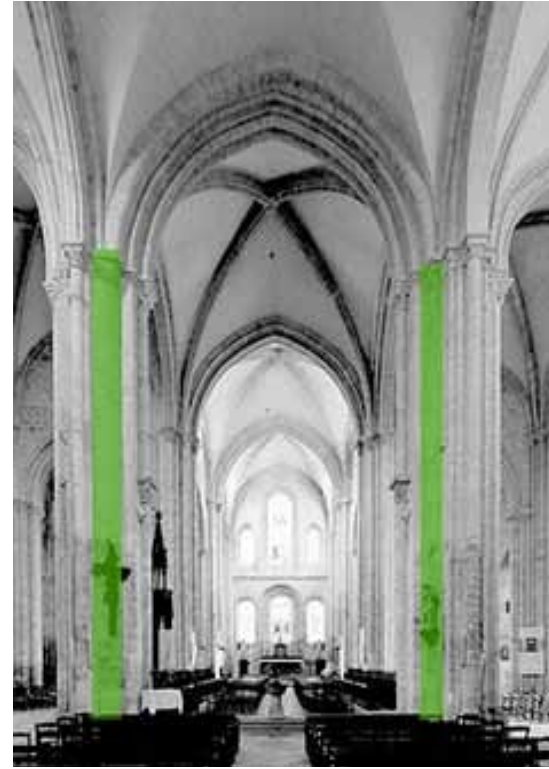
Prolongation of east crossing drums

The two drum piers that peek out of the eastern crossing are 44 courses high [green, right]. The style of the capitals is similar to one in particular in the northern nave aisle [b2], and suggests they were carved about the same time as the others in the nave aisle. Yet the clerestory capitals and their impostes are surrounded by other capitals and impostes from a much later period [below].

There is an enormous difference in height between the clerestory and the aisles. These two in the eastern crossing are in the 44th course, those in the nave aisle are in the 13th. The more than thirty courses between them would, at a normal rate of construction, have needed a number of years to complete.

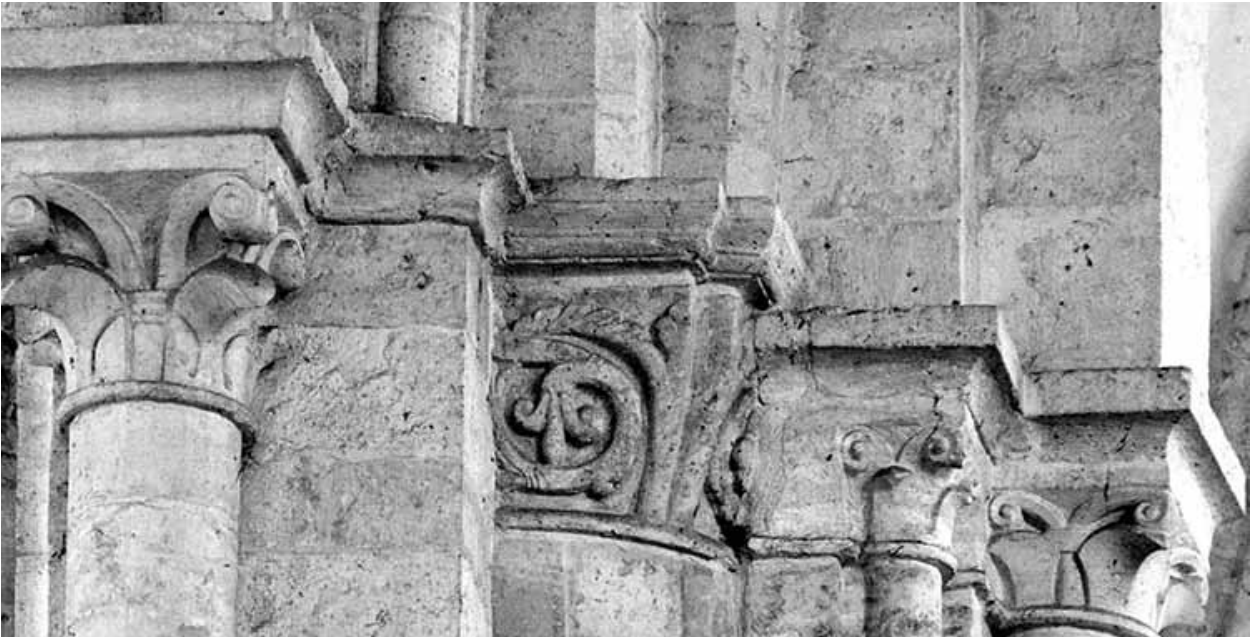
Capitals in the ES1(c+) crossing pier, with part of the drum and its capital visible.

Capital in the EN1(c+) crossing pier

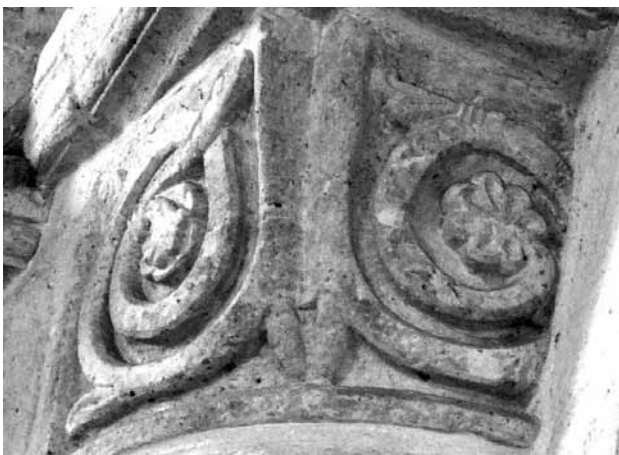
Capital in the WN1(a) nave aisle

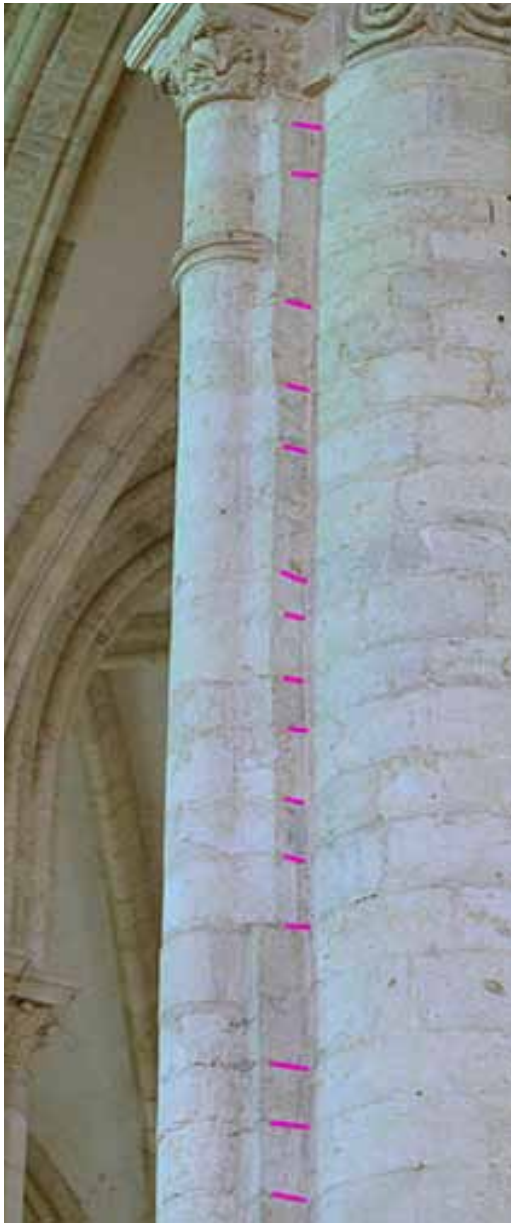
The eastern crossing piers with the full extent of the drums marked and the added pilasters

On three sides they are framed by pilasters that were added over the drums in various stages as the eastern end was reconstructed [right]. This was painstaking work to ensure the small blocks in the pilasters were properly attached to the drums and not likely to be dislodged and peel off under load.

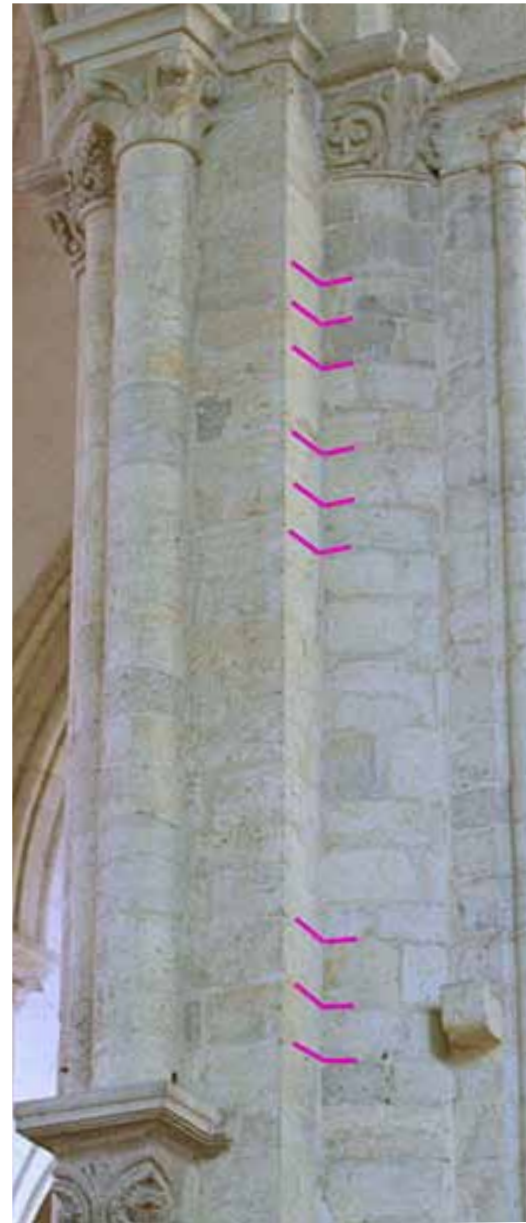
EN1 and ES1 piers with junctions between the pilaster and the drum marked where the coursing appears to be continuous.

Some of the upper pilaster courses are fully bonded into the drums. Each course is marked [below]. Therefore the bonded courses in the drums would have been laid at the same time as those in the pilasters. Let us not forget that medieval masters did not have foot rules, as we do, and as dimensions were derived geometrically the likelihood of cutting new blocks the same size as older ones is remote. The fact they accurately bonded as many as 25 courses shows that that the upper courses of the pilasters were built with the adjacent courses of the drums, and conversely, the higher courses of the drums were contemporary with the pilasters.

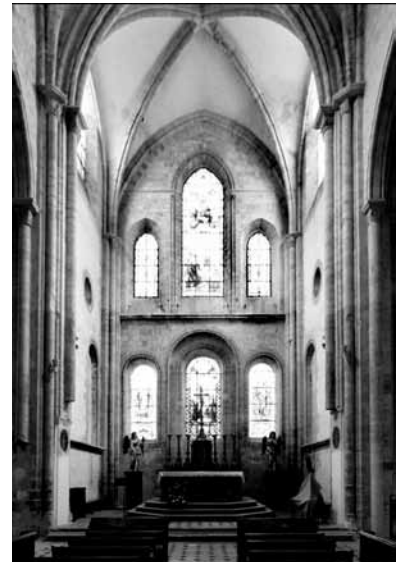
Eastern wall of the choir

In the choir the design of the upper eastern wall and the adjacent lateral windows are unlike the lower, suggesting a significant change to the design above the string course. Round arches compared to steeply pointed, and massive profiles compared to delicate window frames. The lower part is a more stubborn design compared to the elegance in the upper. It is pertinent that the string course between them is at the same level as the string under the nave clerestory windows.

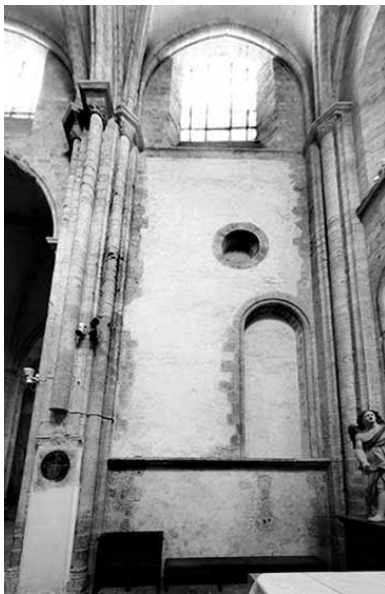
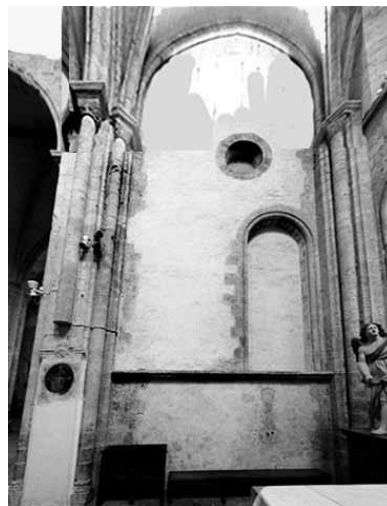
North wall of the east bay of the choir as built, and as it may have been intended.

There are also small oculi on the side walls of the eastern bay that seem uncomfortable [below left], Lateral chapels usually had lower vaults, and we can see that the oculi are off-centre to accommodate the chapel vault on the other side of the wall. There is even a small strip of stonework that could have been the starter blocks for these lateral chapels, but now tidied up and plastered over [below right].

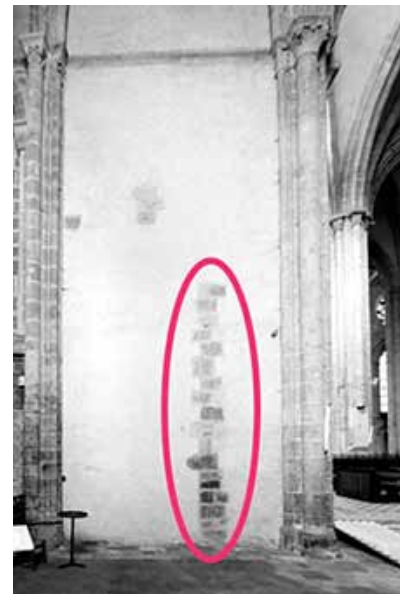
North side of north wall, east bay of choir, with the outline of an intended side chapel outlined.

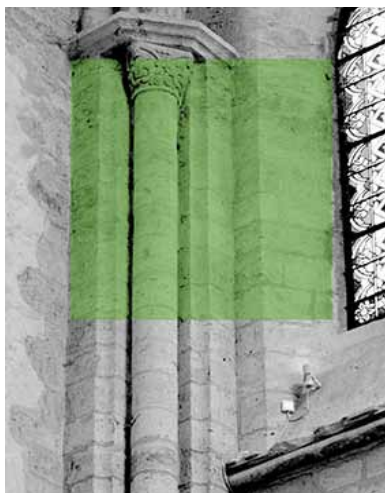
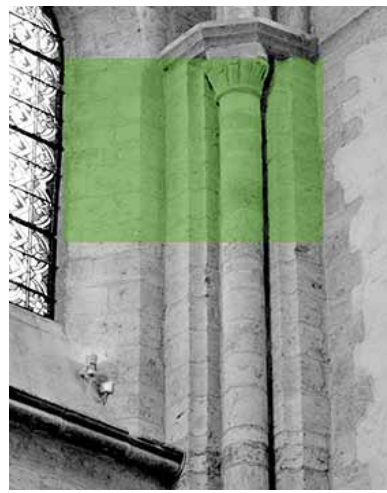
Capitals and supporting shafts on the eastern wall in the choir (c+). Green marks the courses that are bonded into the adjacent windows.

Above the string course on the eastern wall the shafts supporting the two capitals from the 20s are directly bonded into the east wall [marked green, bottom], showing both were built together. Therefore,

these 1120s-style capitals were placed when the wall and its windows was constructed twenty years later.

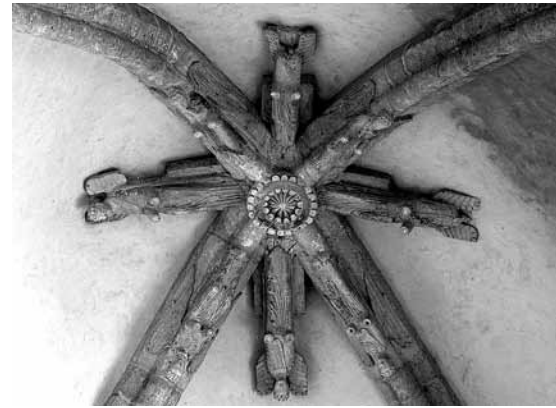
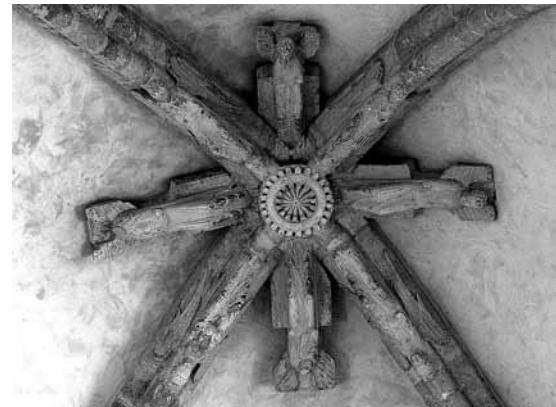
The two four-king bosses in the north, adjacent to the two eastern chapels. I would date them to just after 1140.

The first model [below] shows the choir as built in the 20s and the north catching up around 1140. The northern vaults with the four-king bosses (appropriate for a royal patron) could not be built until the eastern choir walls were ready to be raised, because they share the wall between them in the second model. The external coursing is continuous from the level of the vaults in the north across the upper eastern windows to the upper walls of the chapels in the south.

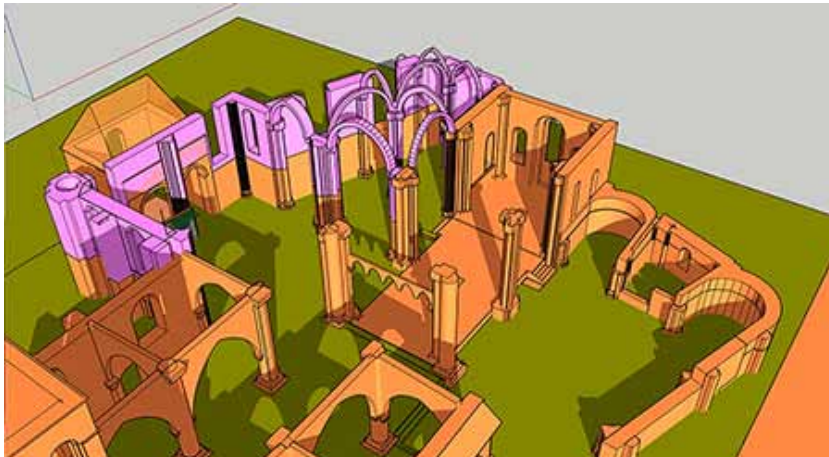
East end with the campaign in the northern chapels [pink], level with the top of the choir

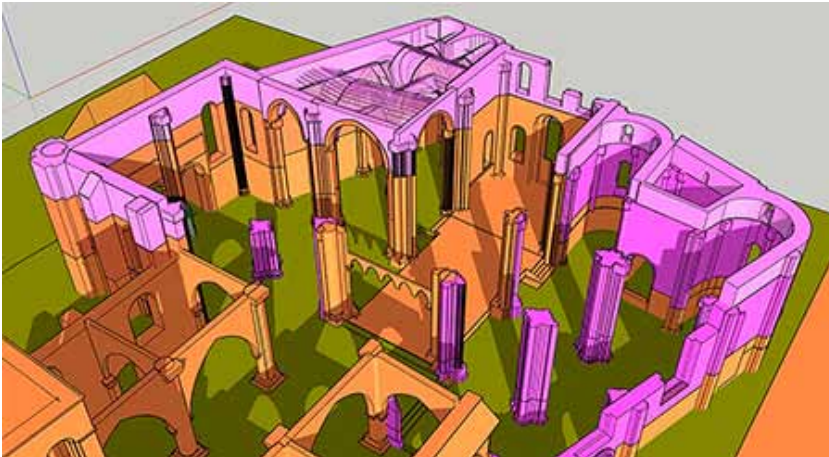
Next campaign with the vaults in the north, continued across the choir to the upper walls in the south

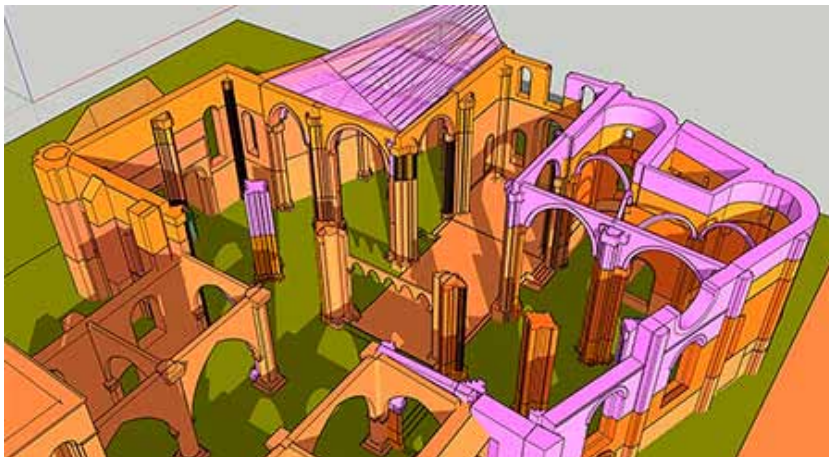
Roof over northern chapels resting on recent wall in the choir, and continuation into the south

The third image shows the next stage in which the masonry on the two sides of the church is inextricably bound. The other choir capitals could

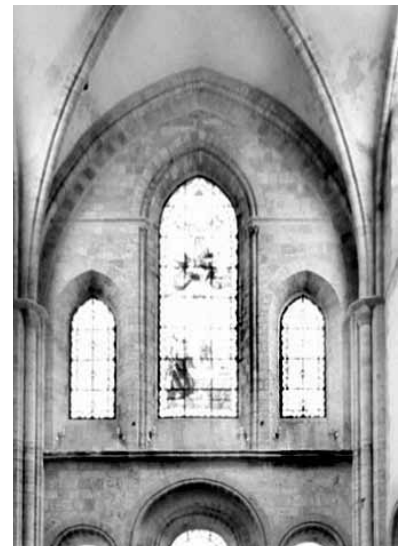
Upper windows in the eastern wall of the choir, capitals on the inside of the central window.

Similarly, the upper window of the eastern choir marked C on the model [right, bottom] are ten courses higher than the A clerestory capitals in the choir at the (c+) level, and were therefore placed after all the walling around the southern chapels had been completed. This campaign would have been after that in the bottom image on the previous page where you can see that the arch over the middle window had not yet begun.

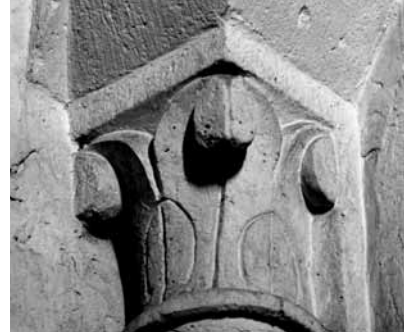
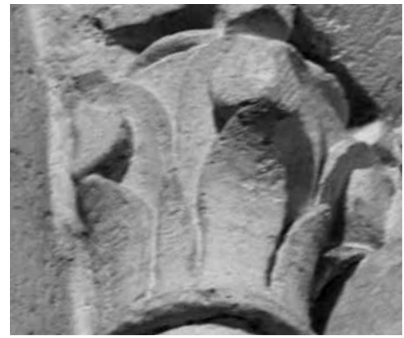
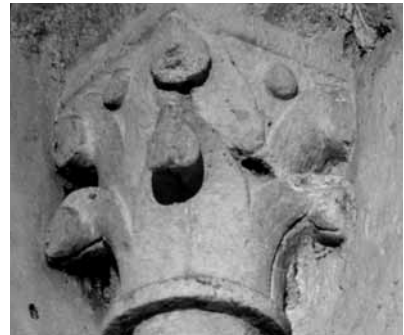
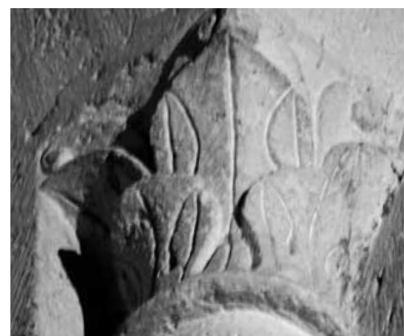
The four capitals in the Treasury (c+) level

This is borne out by the style of the capitals in the treasury nearby that are in the manner of the 1140s [right top]. It is anomalous to have 1120s capitals in the corners at the same level. There are no other capitals nearby, but by following the coursing in the model [below], the upper clerestory capitals marked A are about the same level as those in the treasury marked B.

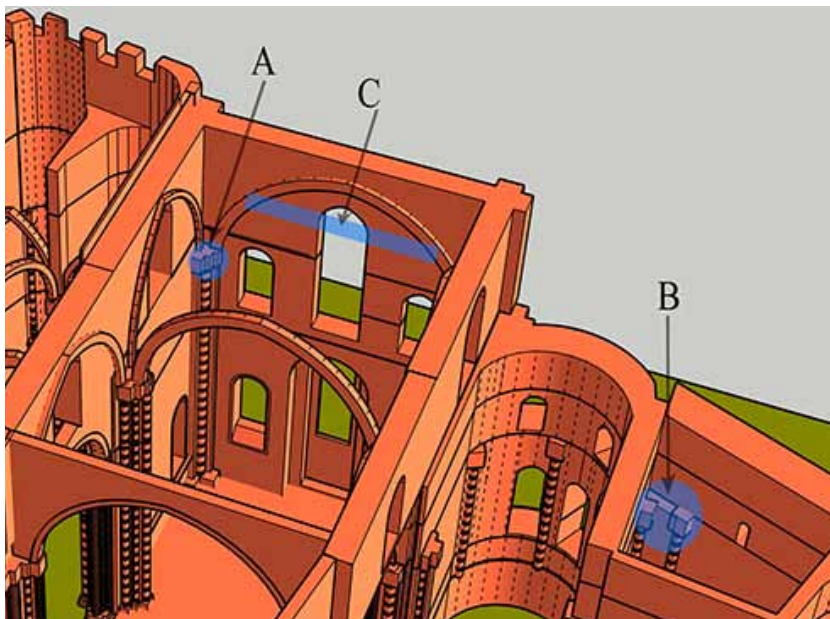
Model of the eastern choir with the roof removed. Connections to the adjacent chapel and treasury noted

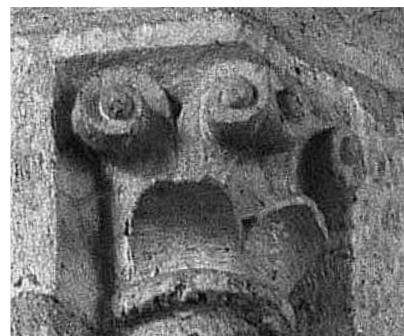
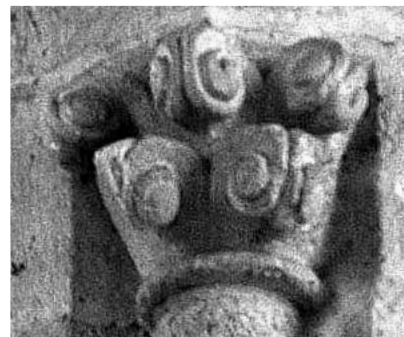
The two choir clerestory window capitals

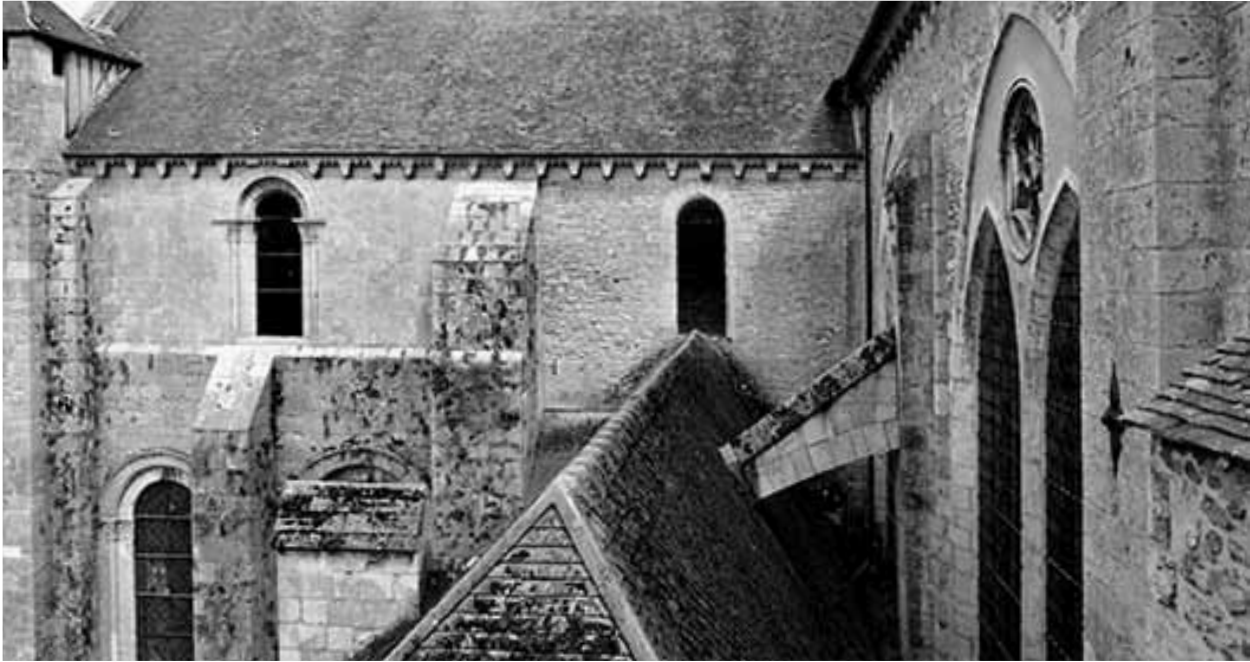
Rubble wall in first bay of north transept and the north wall of the nave

Most of the upper church is constructed of excellent ashlar, except in the clerestory level of the nave and the adjacent bays of the transepts [marked red]. The exterior of these walls are built of rubble. They look contemporary, though you cannot be sure with rubble. The junctions between the rubble and the adjacent ashlar buttresses are butted, whereas if the wall and the buttress had been built together the ashlar would be toothed into the rubble to hold the two masses together. There are some 16 courses of ashlar in the flanking buttresses that are not bonded into the rubble, and the vertical joint suggests the ashlar was placed first.<sup>10</sup>

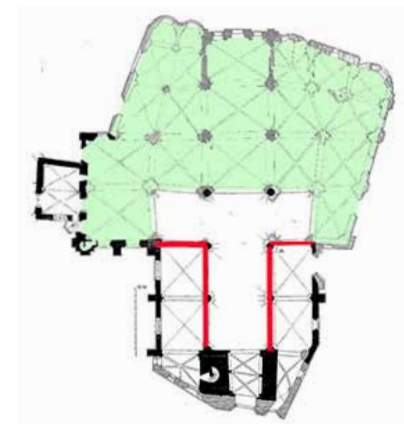
Rubble walls red, partly completed Third Church green.

During the fifty years that separated the nave aisles from the rubble construction a large space remained unfinished. For some two generations the clergy were able to continue with services in the Second Church with limited interruptions while the noise and dust of building work was concentrated on the construction of the Third Church [right, green].

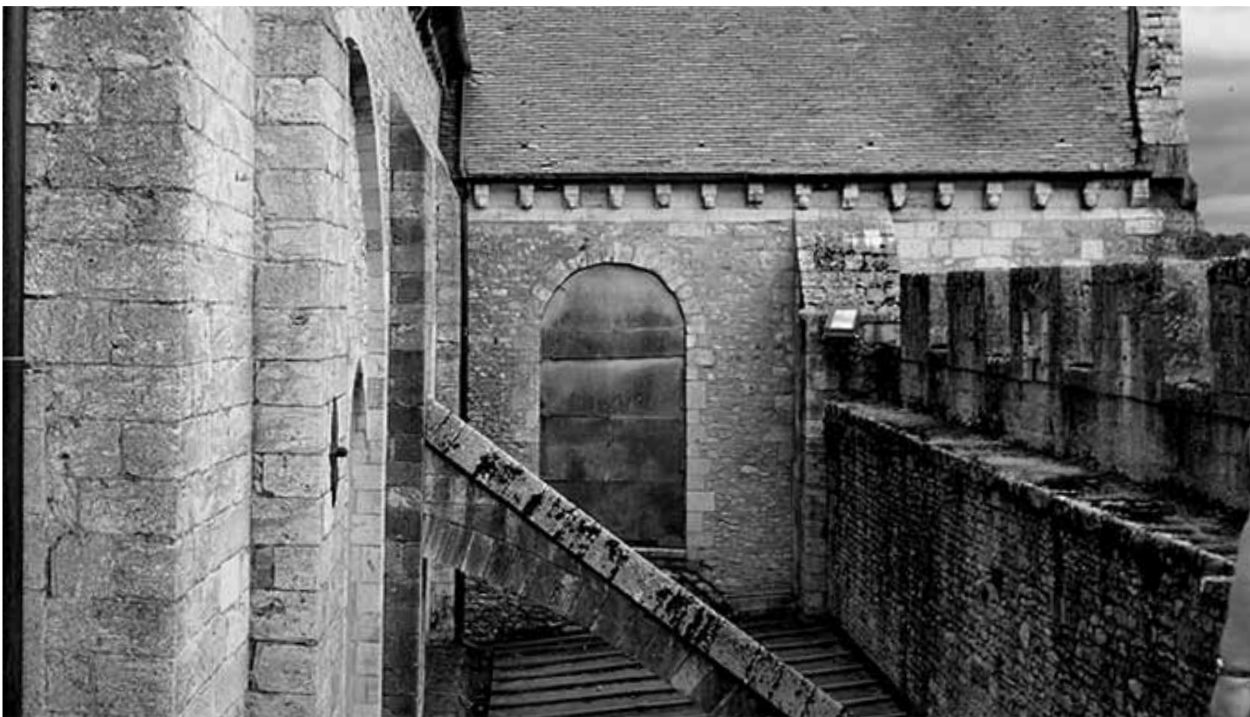
Rubble wall in first bay of south transept and south wall of the nave

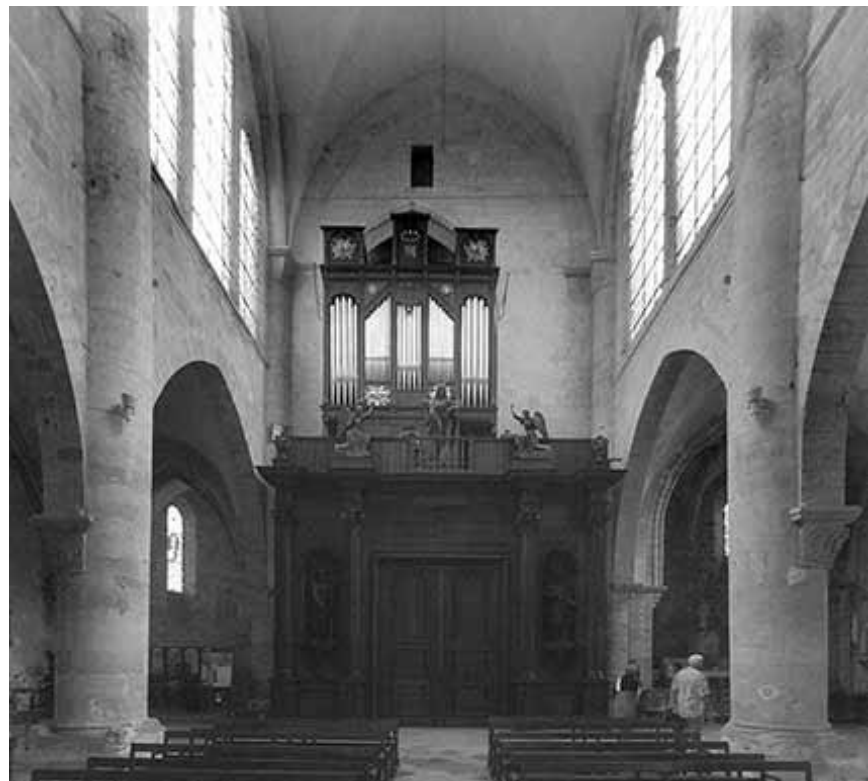
West wall of nave with opening into organ loft that was built with vaulted chamber behind.

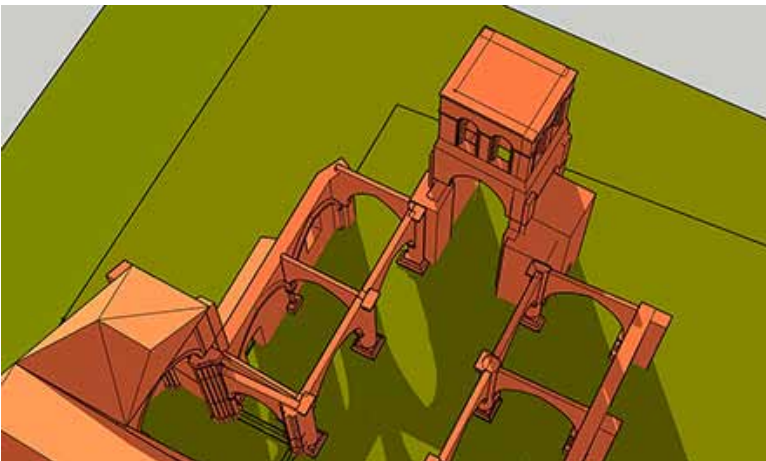
The tower from the First Church and three-bay nave of the Second Church

The four stages from the model [above left] show the state of the works with the roof removed from the nave, and the four levels of the tower as it would have been during the twelfth century,

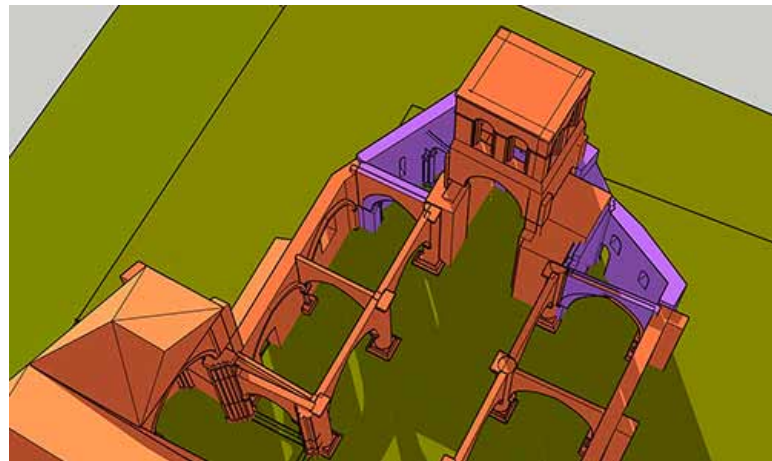
Completion of western aisles and the three portals on the facade

In the second, two aisles have been added at the western end, and at the same time in the third [lower left] two stories of masonry were inserted into the tower. There are arches in the lower level and vaults in the upper. It was at this time that the western nave clerestory capitals would have been raised [dark blue]. The inserted masonry may be more clearly seen from underneath with the floor removed [bottom, next page],

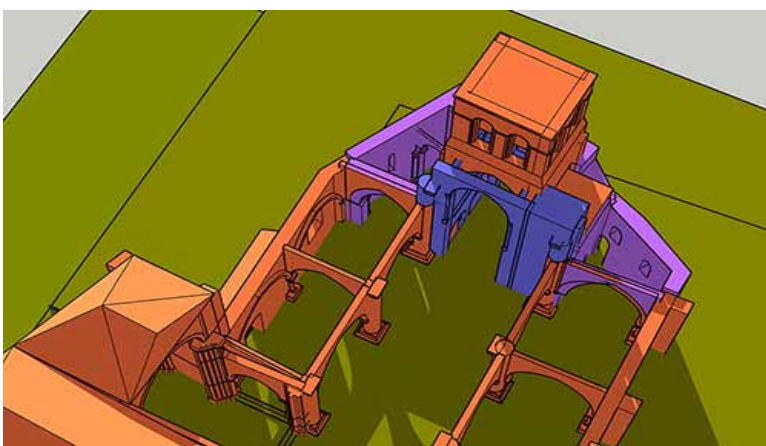
Strengthening the interior of the tower, walling and drums of the nave

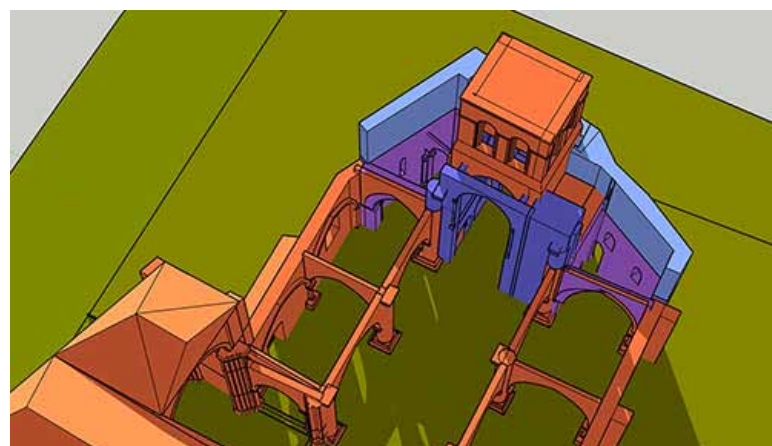
Upper walling and western window to buttress the spire

In the fourth image, weighty vaults and thick outer walls were added to hold the lower courses down, secured into the earth, as it were. This included the extension of the wall and the crenellations to both sides. They are pure showmanship that enlarged one's first impression of the church as approached from the pilgrim's route to the west, an advertisement, a competitive "showcase of the power of the chapter"<sup>13</sup> [top, next page].

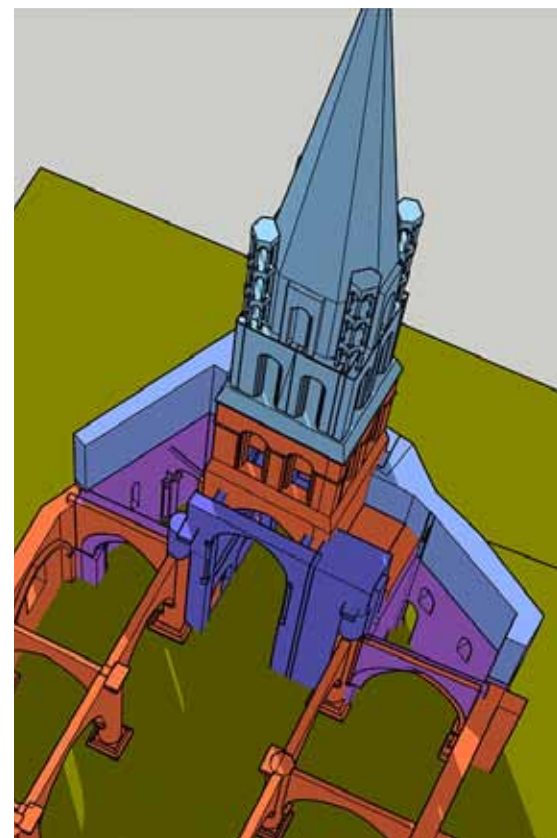
Completion of the Fourth Church with the spire

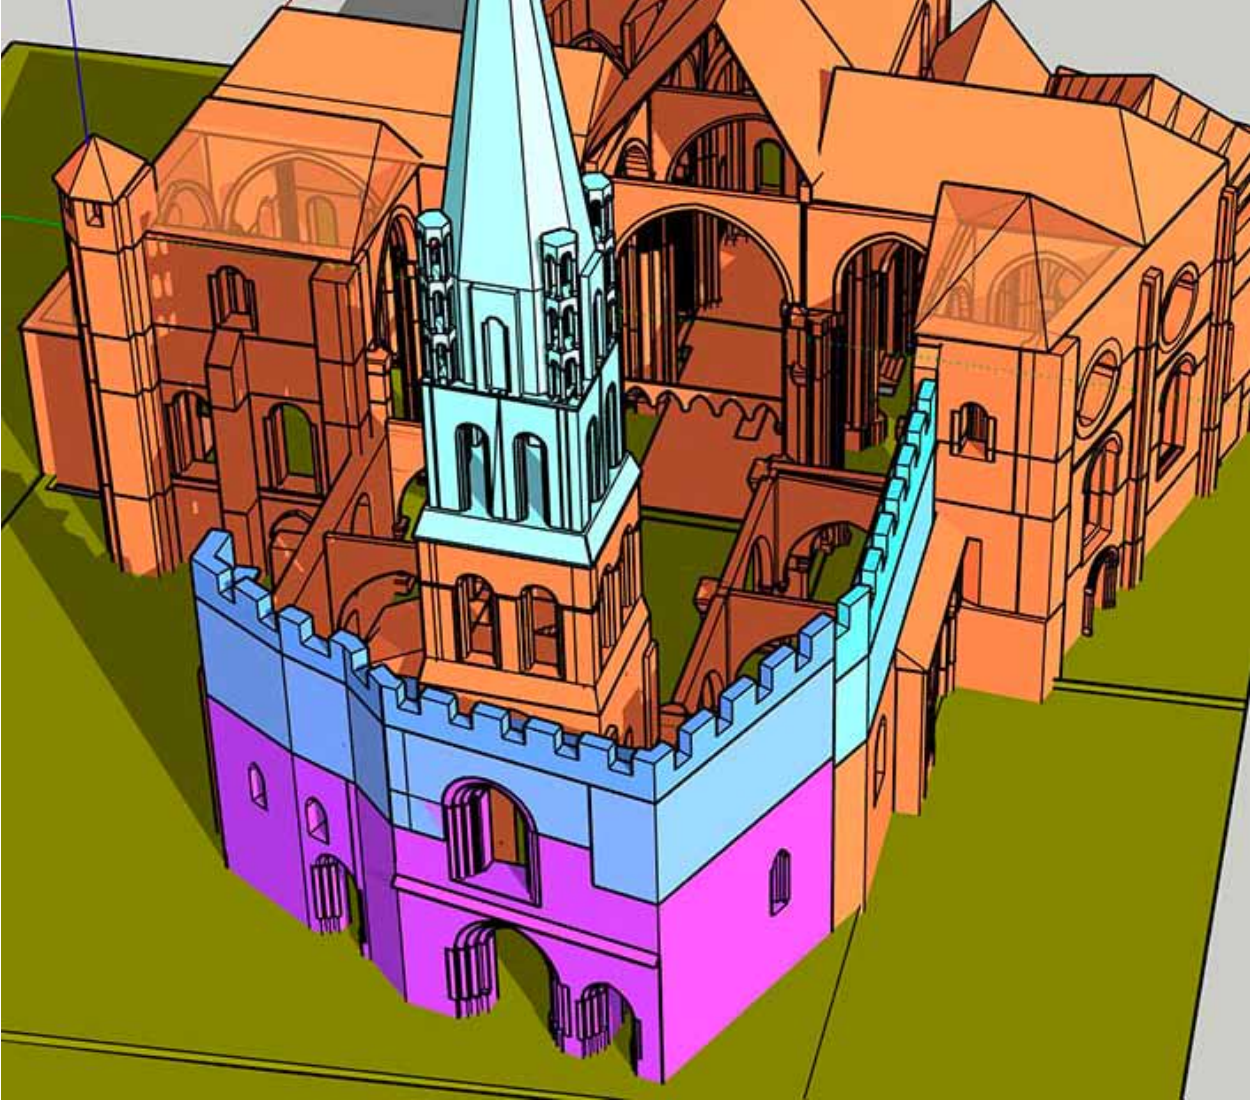
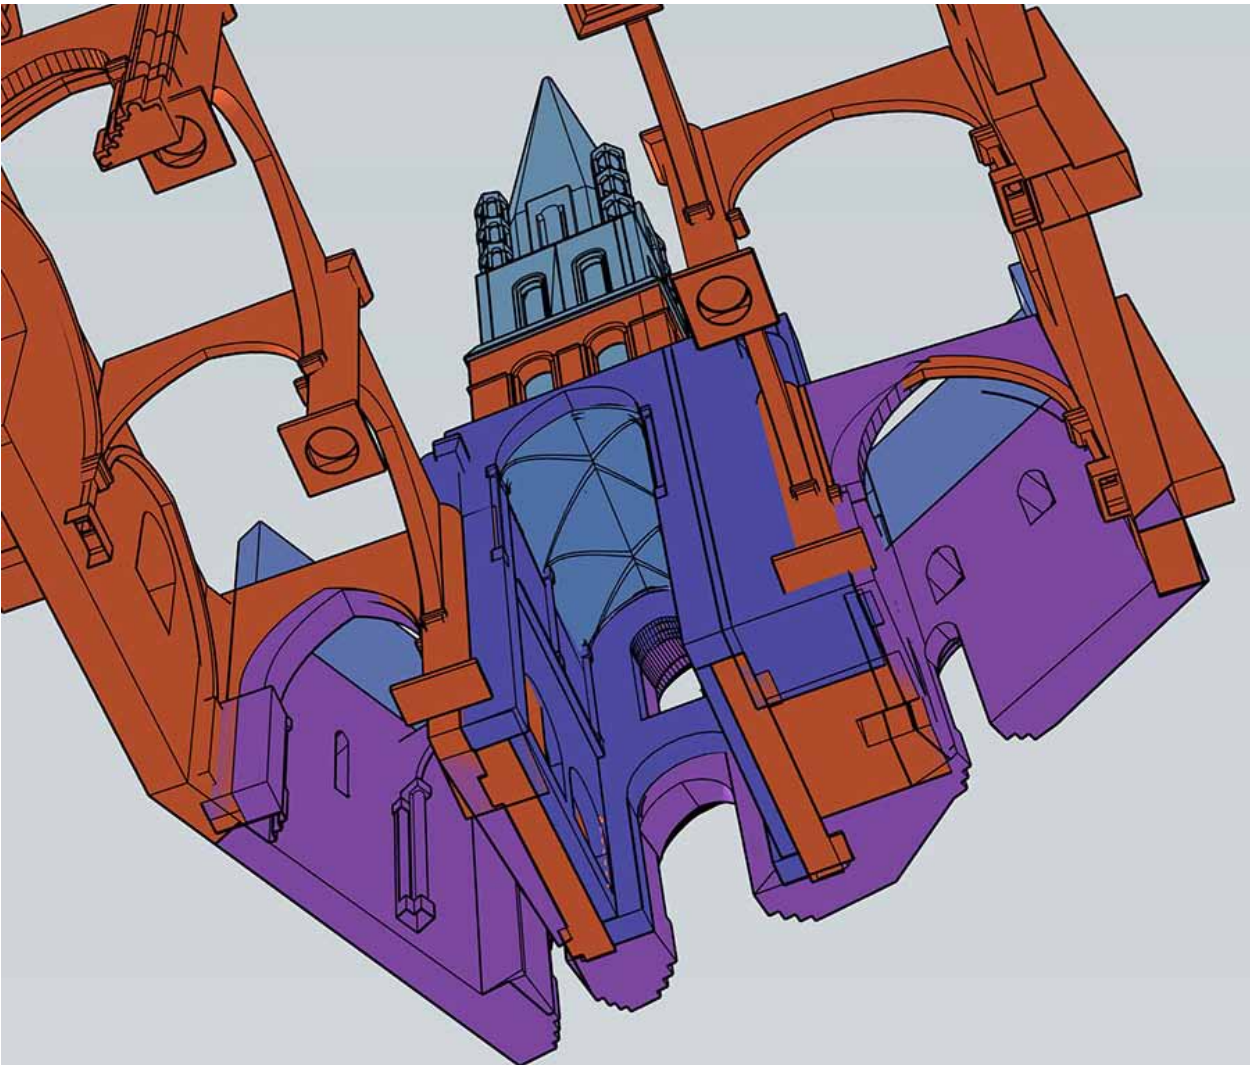
The massive underpinning on three sides needed to stabilise the spire (above) with the crenellations essential to monumentalising the facade. The detailed reinforcing on the interior of the tower and adjoining aisles (below).
