## Raising the capitals at Notre-Dame d'Etampes

John James

August, 2020

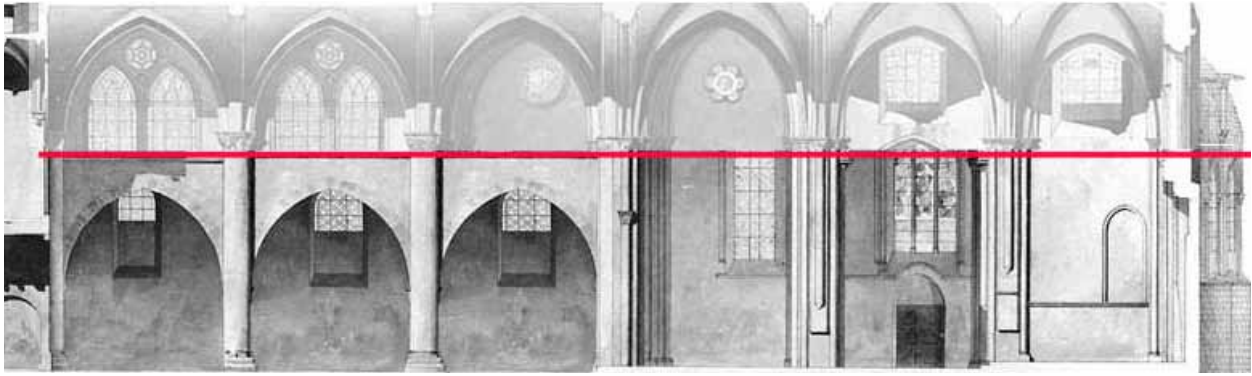
Section through the Second Church with the level of the string course marked in red. The arcade arches for all three nave bays have been included

The section [above] shows that before the east was enlarged in the later 1130s, the church consisted of a three-bay nave and a three-bay choir, without crossing or transepts, and with drum piers in the nave and simple compounds in the choir. The evidence for the arcade arches in the third bay has been lost behind the pilasters, though restoration of the north side in the 1840s did uncover possible springers for one arcade arch.<sup>16</sup>

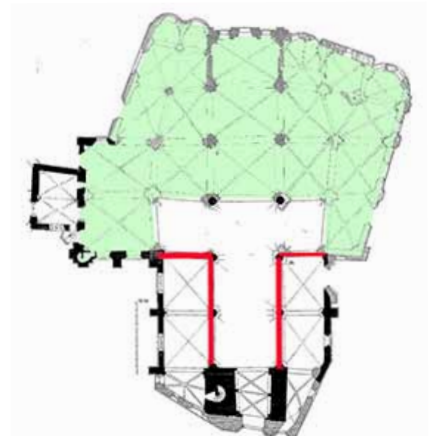
Rubble walls in red, partly completed Third Church green.

All the above issues support the argument that there was something in the way that prevented the completion of the nave and three crossing bays at the same time as the eastern campaigns. The model showed that the simplest explanation was the roof over the nave that had been built only as high as the string course marked by the red line in the section, and the need to maintain services during construction. Above the red line are the vaults that may have been intended, shown faded. Because the nave was originally of three bays the roof also covered the three bays of the future transept [right].

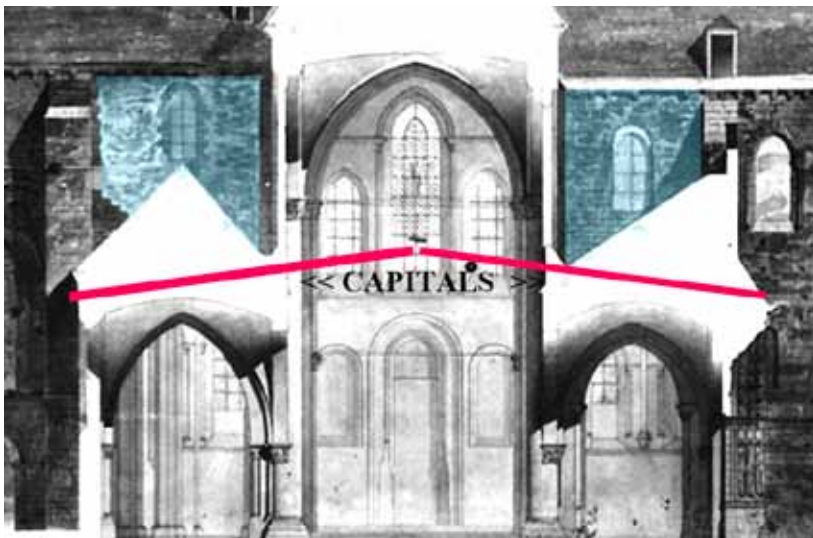
Section through the nave showing an approximate location for the roof over the partially completed works.

Returning to the panels of rubble, marked blue in the section [below], the height and mass of the temporary roof could have certainly delayed work in the west. It would have been natural to build these clerestory

From one east to west the red line defines the (c) level on the 33rd course, and thus the lower silhouette of the building of the 1120s. These six bays and their flanking aisles - and let us not forget the chamber to the north - would have become the only available liturgical space while the new work was being built, for locals as well as pilgrims. Leaving the temporary roof in place for as long as possible to maintain services could have been the most economical and logical decision.
